Near Field Effects of Hidden Seismic Faulting on a Concrete Dam

ABSTRACT

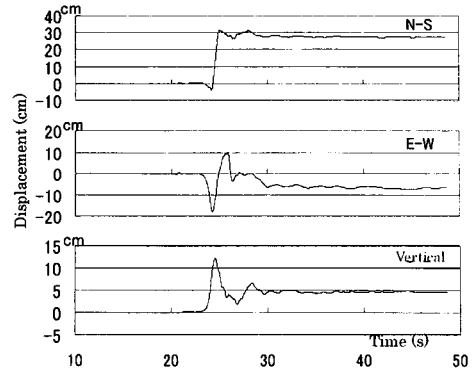
Fig. 5 Displacement histories obtained by integration of acceleration records

Figure 5 shows that the dam underwent different modes of displacement in three directions. In the N-S direction, it was displaced linearly to the north with a final permanent displacement of 27.6 cm. In the E-W direction, displacement varied sinusoidally with a final permanent displacement of 6.5 cm to the west. In the vertical direction, displacement showed a sharp upward peak with a final permanent uplift of 4.7 cm.

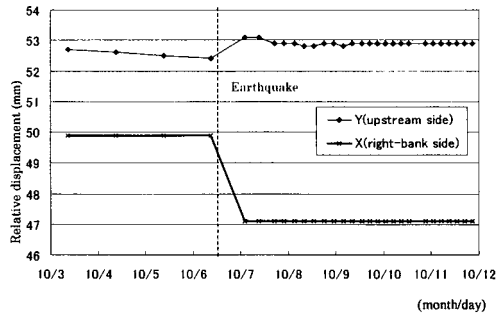
Fig. 12 Relative displacement evaluated from plumb line readings

To detect the relative displacement between the top and bottom of the dam, a plumb line was installed in a vertical shaft 30 cm in diameter. The upper end of the steel plumb line is fixed to the floor of the upper elevator room next to the strong motion accelerometer, and the weight on the lower end housed in a measurement device located at EL 89.5 m in the lower inspection gallery. Automatic measurement usually is conducted a few times a day. Readings from the measurements from October 3 to October 13 are plotted in Fig. 12. The main shock induced a relative displacement of -2.8 mm in the x (right bank) direction and 0.7 mm in the y (upstream) direction, with a resultant permanent displacement of 2.9 mm.

If the relative displacement indicated by the plumb line readings is attributable to the inclination of the dam body produced by earthquake-induced ground displacement of its foundation, then the inclination is quantitatively given by the resultant displacement divided by the length of the plumb line; $2.9/34900 = 8.3 \times 10^{-5}$. In the vicinity of the dam, the inclination of the earthquake-induced ground displacement, as estimated from the simulation, is 6×10^{-5} (Fig. 11). Although this value differs slightly from the inclination determined from plumb line readings in terms of magnitude and direction of inclination, it is reasonable to assume that the dam site was displaced by the seismic faulting of the main shock, as inferred from integration of the strong-motion acceleration.

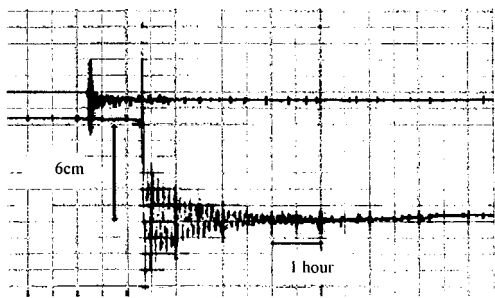
Fig. 13 Records of the reservoir water level at Kasho Dam

ry at the time of the earthquake is shown in Fig. 13. The upper and lower histories in the figure respectively are records with low and high resolutions. They indicate that the water level dropped suddenly by about 6 cm at the time of the main shock, followed by damped free vibration that continued for several hours.

Seismic faulting caused uplifting of the dam body and change in the ground slope of the base of the reservoir as a result of near-field ground displacement. These factors are regarded to constitute the main cause of the sudden drop in the reservoir's water level. A schematic explanation is given in Fig. 15, in which the dam and ground slope before and after the main shock respectively are indicated by thin and thick lines. In the figure, ΔH_1 is the water level change due to the increased reservoir capacity estimated from the average settlement of the reservoir area, and ΔH_2 is the water level change due to the uplifting of the dam. The simulated displace-

ments (Fig. 7) give ΔH_1 of -1.5 cm and ΔH_2 of 2.5 cm, with a corresponding water level change of -4.0 cm ($\Delta H = \Delta H_1 + \Delta H_2$), which is in reasonable agreement with the observed -6.0 cm.

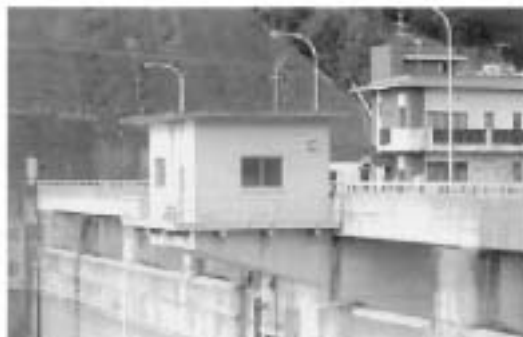
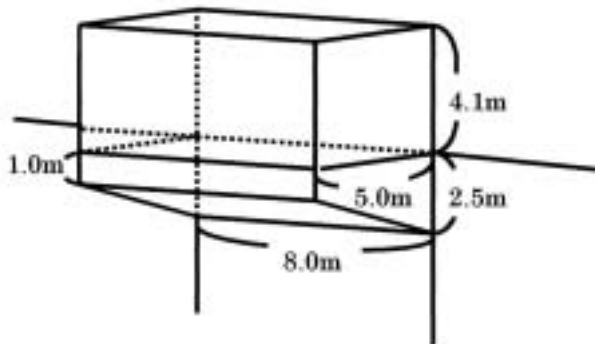
Fig. 21 Sub-gate control room and its dimensions

In the sub-gate control room, concrete was cracked on the floor and sidewalls after the main shock. As shown in Fig. 21, the room is supported by cantilever beams at the center of the dam crest.

The sub-gate control room suffered cracking of its concrete floor beams due to intense shaking during the main shock. The cracks were repaired by post-tensioning with steel bars, resulting in increased beam rigidity. The effectiveness of the repair work was confirmed from micro-tremor measurements. Based on the experiences at this site, it is strongly recommended that the earthquake response not only of the dam body but of appurtenant structures such as sub-gate control rooms be considered in the structural designs of dams.

The cracks in the cantilever floor-beams were repaired by post-tensioning with steel bars, shown schematically in Fig. 22. Before and after the repairs, micro-tremor measurements were conducted at points on the dam's crest and inside the room. Fourier spectra of the velocity components recorded at Point B, before repair work began, are plotted in Fig. 23(a). The vertical component had the largest amplitude and a peak period at 0.1 s. Spectral ratios of the vertical components between Points A and B are plotted in Fig. 23(b). The peak period apparently was shortened from 0.1 to 0.07 s after the repairs, indicative of a remarkable increase in the rigidity of the cantilever beams as a result of post-tensioning.
