Reconnaissance report of the 2004 Great Sumatra-Andaman, Indonesia, Earthquake – Damage to geotechnical works in Banda Aceh and Meulaboh –

Tetsuo TOBITA¹, Susumu IAI¹, Banta CHAIRULLAH² and Wimpie ASPER³

¹ Disaster Prevention Research Institute (DPRI), Kyoto University

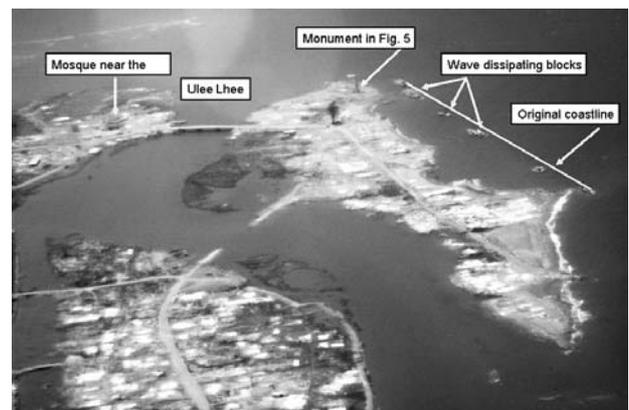
The coastlines of Banda Aceh receded several hundred meters after the tsunami (Fig. 4). Houses located on sand dunes near a small fishery port at Ulee Lheue were completely swept away from their foundations, and only wave-dissipating blocks remained about 20 m off the seashore (Fig. 4). Based on measuring the difference in the water mark heights on the front and rear walls, the current speed was estimated to be 25.2 km/h (Matsutomi *et al.*,

Fig. 4 Aerial view of lost coastline near Ulee Lheue (taken on March 4, 2005)

Results of the reconnaissance indicate that the loss of land along coastlines submerged into the sea was mainly due to erosion by the hydrodynamic force of tsunamis; however, liquefaction also likely contributed. According to the witness accounts of residents, liquefaction occurred before the tsunami struck. The sites consist of clean sand with an average particle size of 0.2 - 0.3 mm (Fig. 6). The epicentral distance of the liquefied site in Banda Aceh, although it might not be the farthest site for this event, can be plotted in the figure developed by Ambraseys (1988) from the worldwide database of shallow earthquakes (Fig. 7). As seen in Fig. 7, the distance between Banda Aceh and an epicenter of 250 km for an earthquake of M_w 9.3 is consistent with existing findings.

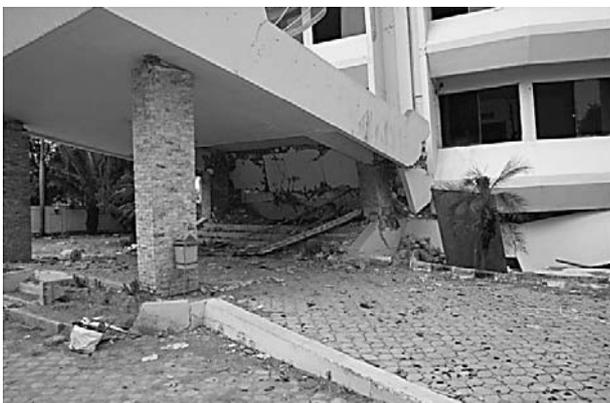
As the city was built on predominantly soft soil, large RC structures such as government and private buildings, shopping centers, hospitals and hotels (Fig. 3), whose natural period was relatively long, were damaged by strong motion. However, it should be noted that damage to those buildings varied from total collapse to minor damage depending on the type of foundation, local ground conditions and spatial variation of strong ground motions. The sharp contrast in the damage that occurred in the coastal and inland hilly area indicates that the soft ground conditions might have been a significant factor in the damage to buildings in the coastal area of Banda Aceh.

Fig. 3 Soft-story (1st story) collapse of a 5-story building

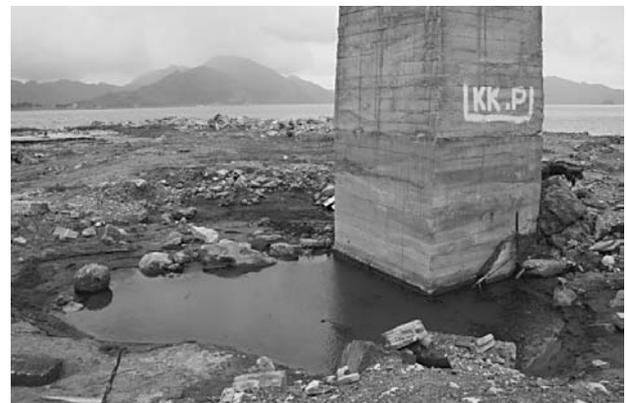
Fig. 5 Erosion behind the monument located at Ulee Lheue

2005). The inundation height of wave at Ulee Lheue Port was 12.2 m above the sea level. There was a local scour behind a monument standing near the fishery port and that might indicate the speed of waves (Fig. 5).

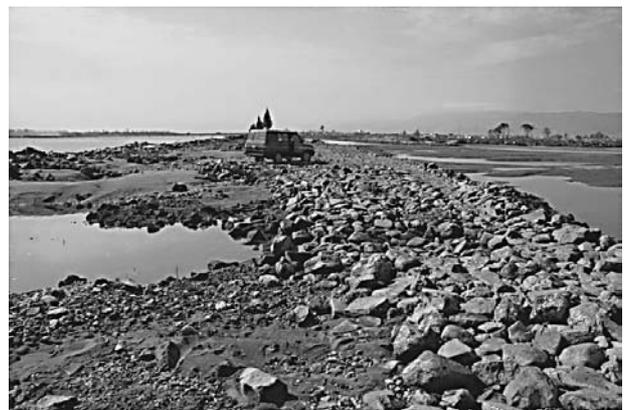
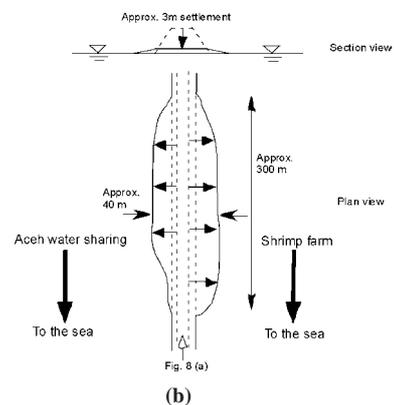
witched by the water channels, i.e., the Aceh River and the straight channel that connected the marshlands of shrimp farms to the sea. Significant damage was found on the left bank of the channel about 1 km from the river mouth (Fig. 8), where marshland and the straight channel merged. The levee's body was laterally expanded in the transverse direction with remaining slope-protection stones, and its crown settled near the water surface (Fig. 8b). Taking account of its failure mode and the ground water depth at the site, the damage could be due to loss of bearing capacity with liquefaction.

Considering that the right bank near the river mouth was more eroded than the left bank, the tsunami waves might have initially struck the right bank and then been reflected to the left bank. This may indicate a north-west incidence of tsunami waves at this location. The wave velocity was estimated from the collapsed bridge at the river mouth of the Aceh Water Sharing. Its bridge girder was supported by U-shaped concrete slabs attached on to the top of piers. When the tsunami struck the bridge girders, they pushed the upstream side of the U-shaped slabs and as a result girders fell. Based on the dimensions and strength of the concrete, the wave velocity was estimated to be 12 km/h (Scawthorn *et al.*, 2005).

Fig. 8 (a) Collapsed levee (left bank of the Aceh Water Sharing), (b) Schematic view

- (2) Considering the failure mode and surrounding environment, liquefaction might be the primary cause of damage to the embankments of the Aceh Water Sharing. The occurrence of liquefaction at the distance of 250 km away from the epicenter is consistent with the existing data.

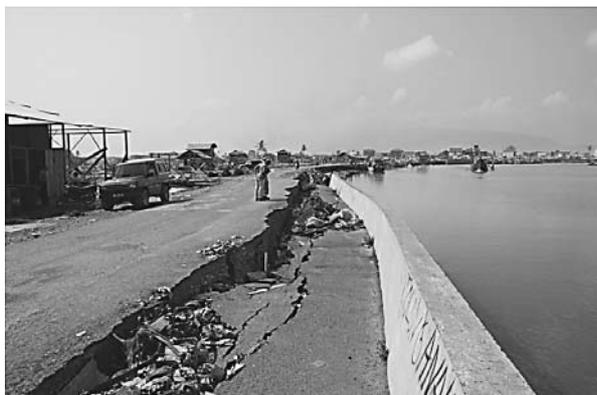
At this location, river protection walls were constructed by L-shaped concrete slabs, whose height was 2 m and the width at the bottom was 1.5 m (Fig. 9 and 10). The walls were displaced toward the river and in some parts totally collapsed. The material behind these river walls was mainly sandy clay and interbedded sands and gravels. Strong shaking and hydrodynamic force might have caused the damage to the river walls.

Fig. 9 Failure of river protection walls at Lampulo

- (3) Damage to the river protection walls at Lampulo where clayey soil was dominant might be due to the retraction force of the tsunami.
- (4) A major road between Banda Aceh and Meulaboh was destroyed. While a major road in the south of Meulaboh was undamaged except for the bridges. This is because the road in the north of Meulaboh was constructed closer to the ocean than that in the south of Meulaboh.

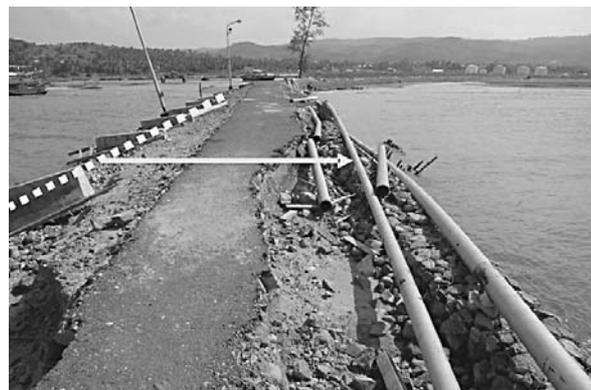
At Malahayati, east of Banda Aceh, an embankment to support oil pipelines suffered minor damage (Fig. 11). Its main body was not cut or submerged in the sea, only its shoulders were eroded; however, pipelines were cut and dislocated to the other side of the slope from their original position by tsunami induced force. The embankment was jutting into the sea about 1 km, and near the end the pipeline was supported by piled piers. The pier and machine cabin were undamaged.

Fig. 11 Minor damage to the embankment for pipelines at Malahayati. Pipelines were dislocated.

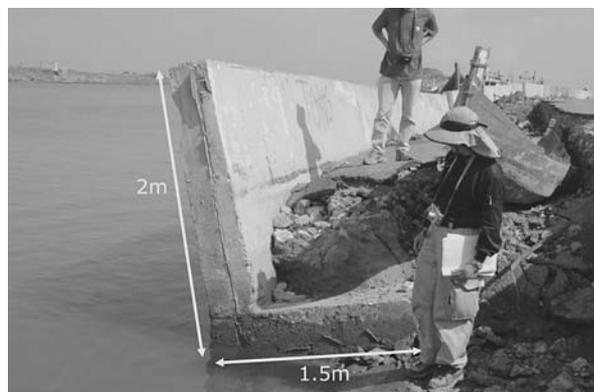
Fig. 10 Tilted and dislocated L-shaped river protection at Lampulo

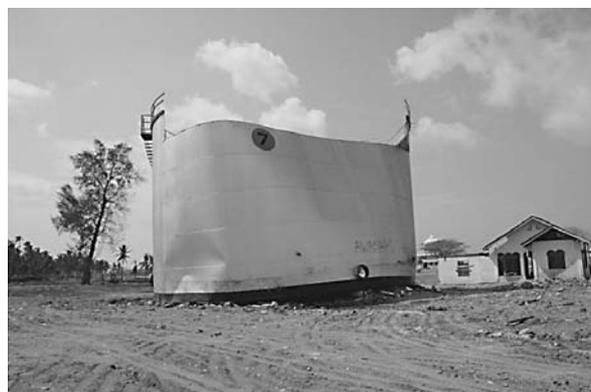
Other remarkable damage at the site was that three oil storage tanks out of nine were washed away by tsunamis due to the lack of anchor bolts (Goto, 2005; Saatcioglu *et al.*, 2006). One was relocated about 300 m west from its original position due to high tide of waves (Fig. 12). There were other relocated large objects, such as a power generating vessel and large tankers, which might have

Fig. 12 Relocated oil storage tank at Malahayati

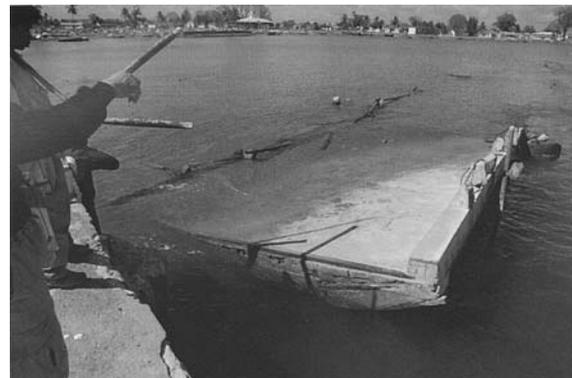
Houses on the Ujong Kalang peninsula (Coral Peninsula) in Meulaboh, except the three-story RC structure of the police department, were totally destroyed and only debris remained. Floor slabs of a pile supporting a passenger jetty were submerged into the sea and only piles were left (Fig. 15).

Fig. 15 Collapsed floor slab of a passenger jetty at a ferry port in Ujung Kalang, Meulaboh)

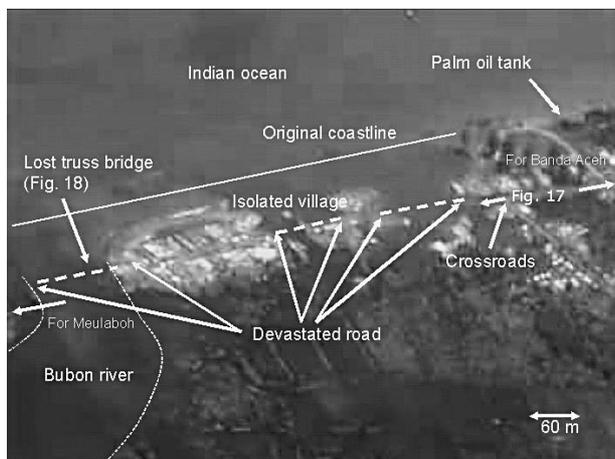
amounts of deltaic deposits were lost up to several hundred meters from the coastline (Fig. 16).

Fig. 16 Aerial view of Kuala Bubon and devastated road (taken on March 2, 2005)

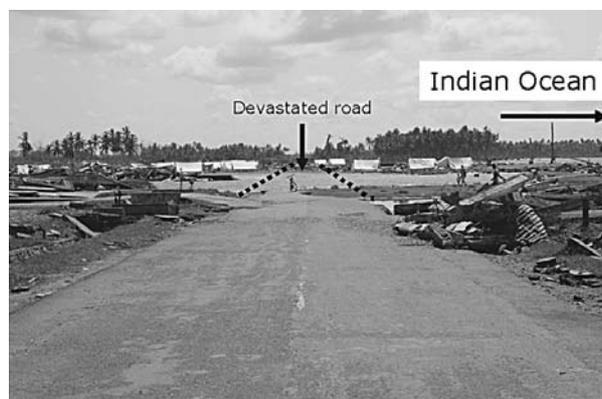
Fig. 17 Devastated road in Kuala Bubon. Photo was taken near the crossroads shown in Fig. 13, 14 and 16

A main road along the coastline of western Sumatra Island, which connected Banda Aceh and Meulaboh, were devastated. In the northern part of Meulaboh, because the road was constructed either on sand dunes near beaches or lowland just behind the sand dunes, parts of the roads, especially near river deltas, were completely lost (Fig. 16 and 17). While in the southern part of Meulaboh, the road was not damaged at all because it was constructed hundreds of meters inland from the coastline. After the earthquake, the main road was shifted to a narrow and unpaved road running inland in between Meulaboh and Kuala Bubon. The amount of traffic on the inland road, therefore, has been increased and protection works of road shoulders have been implemented using stones and mesh wires.

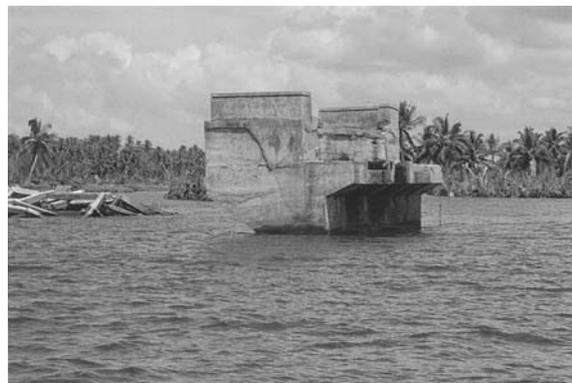
There was a 60 m steel truss bridge at the river estuary of Bubon River (Fig. 14). Its girders fell and only two bridge abutments are left (Fig. 18). Wave force is responsible for the bridge

Fig. 18 One of the bridge abutments of a collapsed steel truss bridge in Kuala Bubon

collapse. However, survivors said embankments to an access road to the bridge abutment settled before the arrival of the tsunami as a result of the strong shaking. People, therefore, could not escape by using bicycles or motorcycles. The settlement may be attributed to poorly compacted soil or liquefaction. This has often occurred after large earthquakes, e.g. vertical gaps at the edge of box culverts or near bridge abutments after the 2004 Mid Niigata Earthquake, Japan (Tobita *et al.*, 2005). In Kuala Tadu, where similar type of damage was observed (Fig. 19), the people tied up palm trees as a temporary bridge to fill the gap between the main bridge girder and the access road. It takes tens of minutes to temporarily repair. Considering the time until being struck by tsunamis, escape routes should be seismically stable.

- (5) Poor compaction and liquefaction might be responsible for the collapse of embankments adjacent to bridge abutments. If this occurs before the arrival of tsunamis, people are unable to use motorcycles and bicycles for quick evacuation. This indicates that it is important for escape routes to be seismically stable.

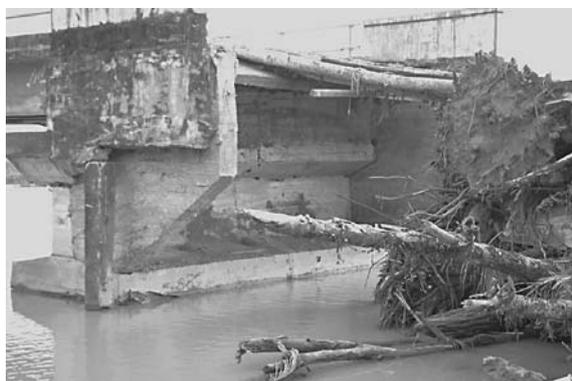
Fig. 19 Lost access road in Kuala Tadu
