Clarifying Suffering of the Elderly in the 2004 Niigata Flood and the 2004 Mid-Niigata Prefecture Earthquake

Keiko TAMURA¹, Haruo HAYASHI² and Reo KIMURA³

¹COE Researcher, Disaster Prevention Research Institute, Kyoto University

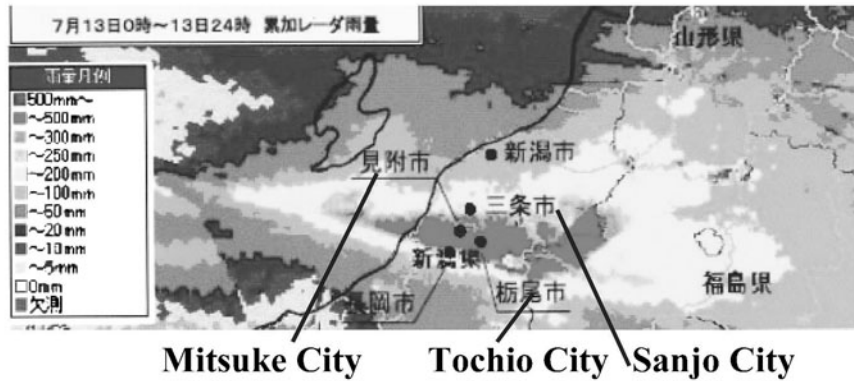
Fig. 3 Cumulative Rainfall (July 13th 0 am-12 pm) in the Affected Area of the 2004 Niigata Flood (Data from the Japan Meteorological Agency)

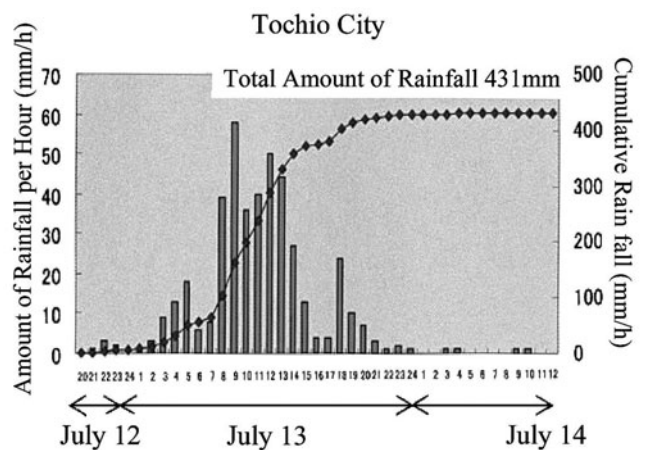
Fig. 4 The Distribution of Daily Rainfall on July 13 and Changes in Hourly Rainfall in Tochio City (Source: “A Quick Report on Heavy Rain and River Disasters in Niigata and Fukushima in July 2004” compiled by the River Department of the Hokuriku Regional Development Bureau and the River Planning and Management Division of the Department of Public Works, Niigata Prefecture)

Rainfall of 431 mm/day was recorded at the Tochio Rainfall Observatory (Japan Meteorological Agency), which covers the Kariyata water system. This heavy rain was the first such experience for the majority of the local people. Looking at hourly rainfall, it is found that it began to rain on the night of July 12 and that rainfall of over 100 mm/hour continued for three hours after 3 o’clock in the morning on July 13. Although the rain eased at one point, it strengthened again and averaged over 30 mm/hour from 8:00 am until nearly 3:00 pm, during which time there was rainfall of about 300 mm. Between 9:00 and 10:00 am and between mid-day and 1:00 pm, the rain exceeded 50 mm/hour, the level at which the Japan Meteorological Agency indicates that the risk of flooding and landslide is high.

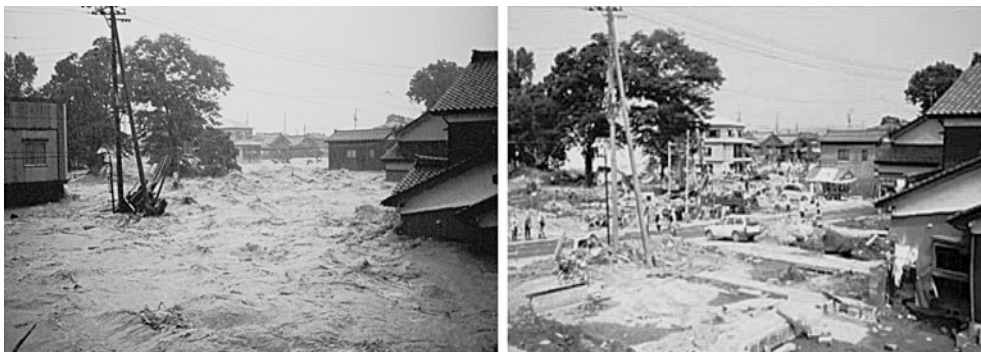
Fig. 12 The State of Flooding just after the Break and Several Days Later near the Broken Bank in Nakanoshima Town (Photos by Mr. Kaichi Murohashi)

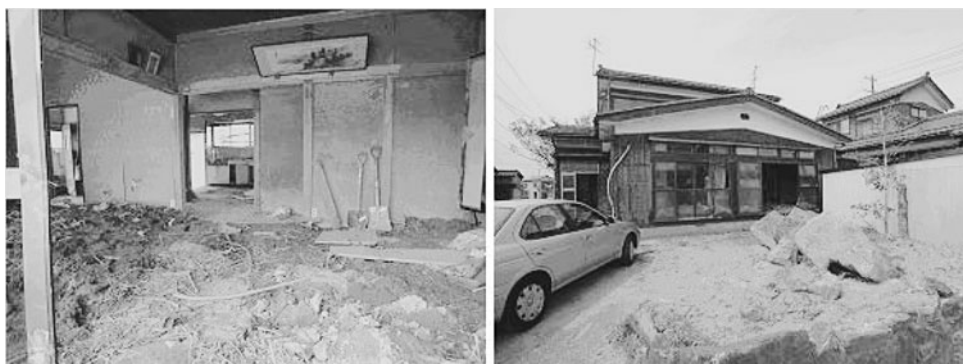
tern are that the victims were found dead outdoors and all three were non-elderly. Even the house closest to the break was about 400 meters distant from it (marked with a small square in Fig. 13). This house was the most severely damaged in this affected area. The severity of the damage is shown in Fig. 14. It was a two-story wooden house. As the house was flooded above the floor and had clay sediment nearly one meter high inside, it looks uninhabitable and abandoned. However, the exterior of the house remains undamaged and it would still be basically habitable if it were cleaned. From the marks left on the neighboring houses, the depth of flooding was estimated to be about 1.5 meters in this area.

Fig. 14 Damage to the House Closest to the Broken Left Bank of the Ikarashi (Photos by Haruo Hayashi)

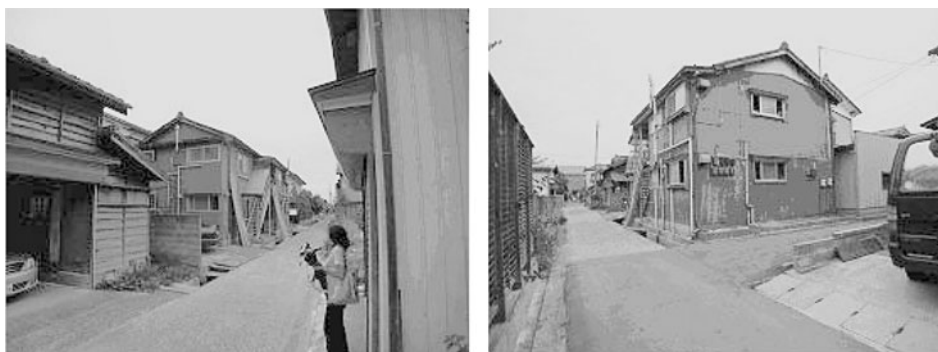
Fig. 16 Examples of the Victims’ Houses in the Western Vicinity of the Shin’etsu Line on the Left Bank of the Ikarashi in Sanjo City (Photos by Haruo Hayashi)

In the two-story apartment house shown in **Fig. 16**, a woman who lived in the left-hand apartment on the first floor died. The whole of this area was flooded up to 1.2 m above the floor. However, damage to the houses cannot be seen from the exterior.
