Investigation of Human Injuries during the July 26, 2003 Northern Miyagi Earthquake with Focus on Furniture Overturning

Takeshi SATO¹, Masato MOTOSAKA¹ and Akira MANO¹
¹Disaster Control Research Center, Tohoku University, Japan

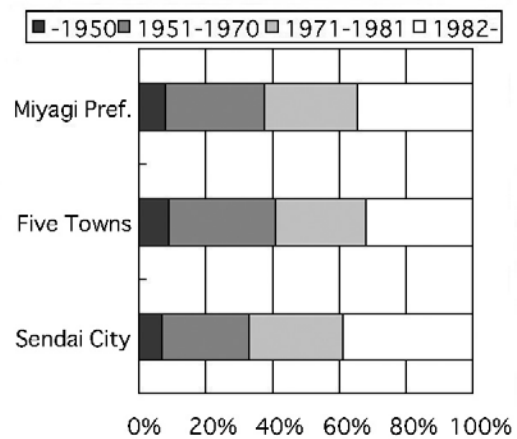
Fig. 3 Classification by construction age for wooden buildings

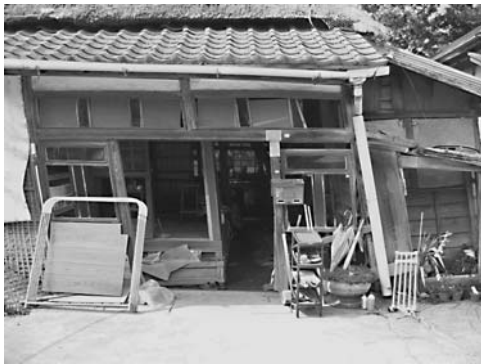
**Photo. 1** Severely damaged wooden house

topographs taken by the authors. A severely damaged old wooden house is shown in **Photo. 1**. A wooden house that had been designed in line with the new seismic code as shown in **Photo. 2** incurred no damage even though it was near the house in **Photo. 1**. This suggests that the seismic performance differs according to age and design. **Photograph 3** shows a collapsed wooden house constructed in 1920. The light roof of this house had been replaced with heavy Japanese tiles 'kawara' without a seismic retrofit of the structural frame. The roof fell whilst maintaining the shape. Structural damage to a wooden house with a soft first story used as a store is shown in **Photo. 4**.

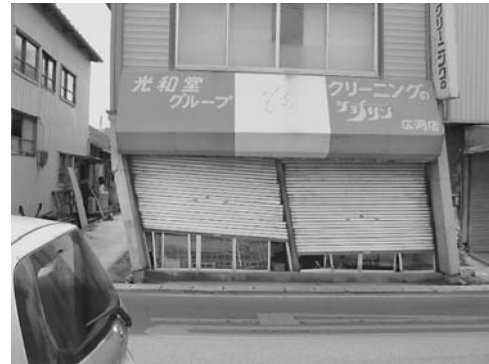
**Photo. 4** Damage of pilotis structure

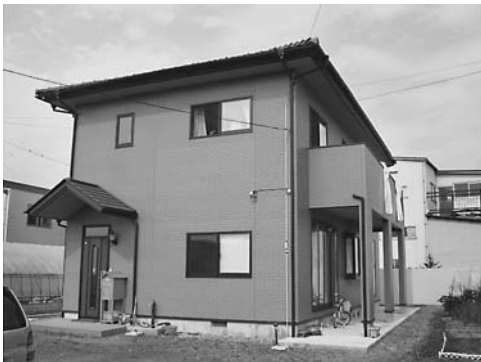
**Photo. 2** Non-damaged wooden house

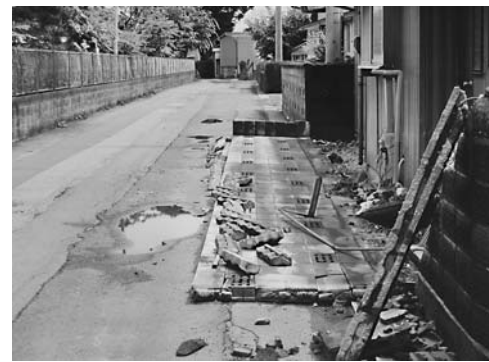
**Photo. 5** Fallen concrete block

In the focal area, many concrete and stone walls were damaged. Similar damage occurred as a result of the Off Miyagi Earthquake in 1978 causing human casualties. A fallen concrete block wall in a school zone is shown in **Photo. 5**. At the time that the mainshock occurred, most people were assumed to be at home. The ratio of people usually at home based on a life investigation by NHK (2000) is approximately 85%. In the focal area, there were few injuries caused by collapsed block walls. Vulnerable structures should be immediately improved in anticipation of a new off Miyagi Earthquake.

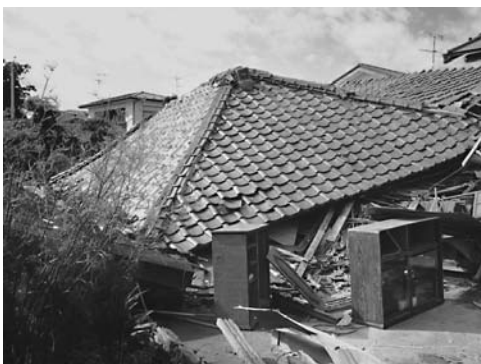
**Photo. 3** Collapsed wooden house

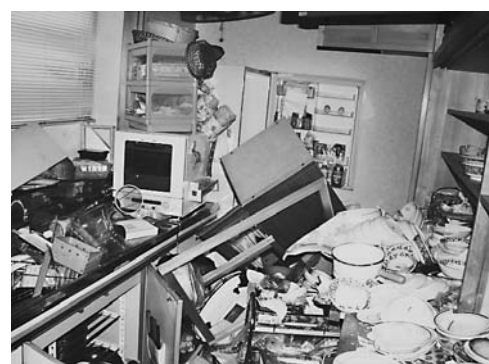
**Photo. 6** Damage in kitchen

Photograph 6 taken by NHK shows indoor damage to a kitchen in Yamoto Town. The mainshock occurred at breakfast time on Saturday morning, which shows that kitchens as well as bedrooms and living rooms require earthquake preparedness.

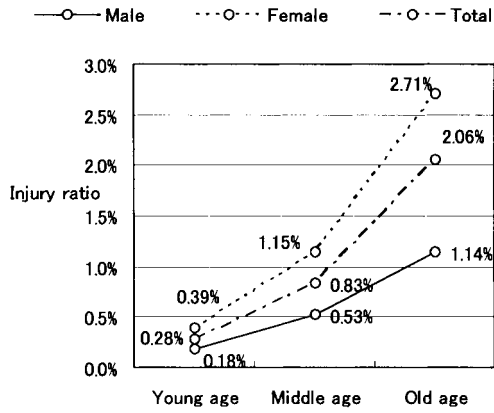
The injury ratio by age is shown in Fig. 8. The IFD data on Yamoto Town was used. The injury ratio increases for older people, reaching 2% for the old age group. This figure also shows the injury ratio by sex. Females have approximately double the injury ratio for all age groups. This tendency occurred in other recent earthquake disasters such as the 2000 Western Tottori Prefecture Earthquake and the 2001 Geiyo Earthquake (Murakami, 2001).

Fig. 8 Ratio of injury by age

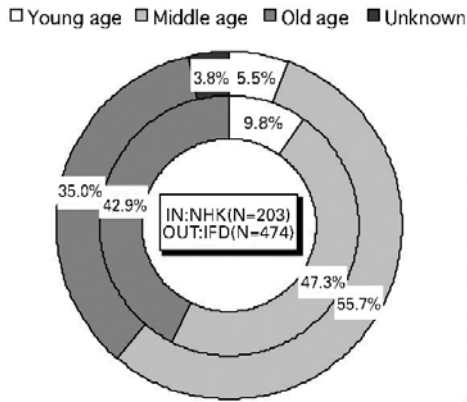
The ratio of injured humans by age is shown in Fig. 9. Injuries in the old age group accounts for approximately 40% of the total. This finding indicates that the aging of society will increase the vulnerability to human injury.

Fig. 9 Injury by age
