The Exceptional Flooding on Vanua Levu Island, Fiji, during Tropical Cyclone Ami in January 2003

James Peter TERRY¹, Simon MCGREE² and Rishi RAJ³

ABSTRACT

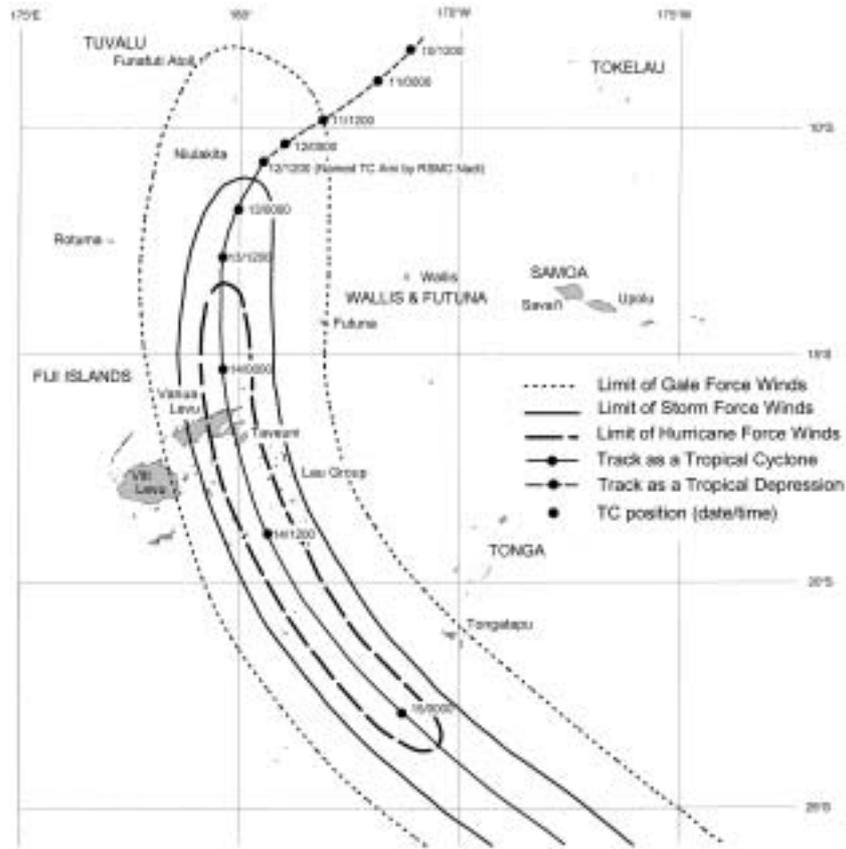
Fig 1. Track of Tropical Cyclone Ami 10-15 January 2003, showing the approximate limits of gale, storm and hurricane force winds.

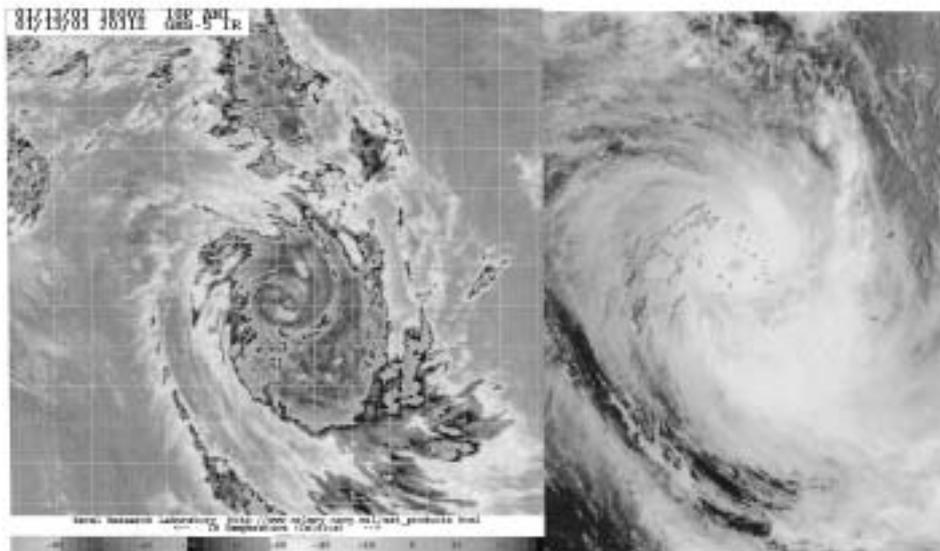
Fig 2. Two satellite images of TC Ami taken at approximately the same time on 14 January 2003 (but at slightly different scales). The centre of the storm is passing through the eastern Fiji Islands (the Lau Group) on a south southeasterly track. The left picture is a thermal image of the upper level temperatures. Right is a visible image showing the organisation of the cloud bands. Source: US Navy and NOAA.

The eye passed the western tip of Taveuni Island after 5 a.m. 14 January. The system then moved rapidly through the Lau Island group (Fig. 2), curving more to the southeast as it did so. At 12 noon 14 January, Ami reached peak intensity while its centre was located about 97 km south-southwest of Lakeba Island. Ten-minute average winds of about 200 km/h with momentary gusts of 230 km/h were reported (NIWA 2003). Ami travelled south-southeast at 22 km/h as it left Fiji waters, maintaining hurricane intensity.

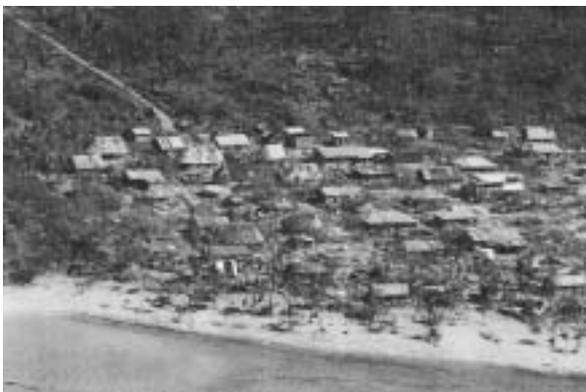
Fig 3. Destruction by TC Ami of a village in the Lau Islands (see Fig. 1) of eastern Fiji. Source: Fiji Navy, supplied by the Fiji Ministry of Information.

The destruction caused by TC Ami was extensive and severe (e.g., Fig. 3), across Fiji's Northern and Eastern Divisions, especially to roads, the infrastructure, buildings, houses, farm animals, crops, and natural vegetation. The confirmed number of fatalities was 14 and 3 people were counted as missing. Communications to and within the two divisions were cut for several days, and Fiji's Disaster Management Centre declared Vanua Levu Island a natural disaster zone. Massive waves and strong storm surges led to both coastal and inland inundation in many areas along Ami's path. Deep flooding in Labasa on Vanua Levu had severe effects on the town's population (Fig. 4) and posed serious health and environmental risks. Domestic water supplies were badly disrupted, leaving residents without clean drinking water and forcing the Fiji Government to transport potable water from mainland Viti Levu Island to affected areas. Torrential rain led to many valley slopes

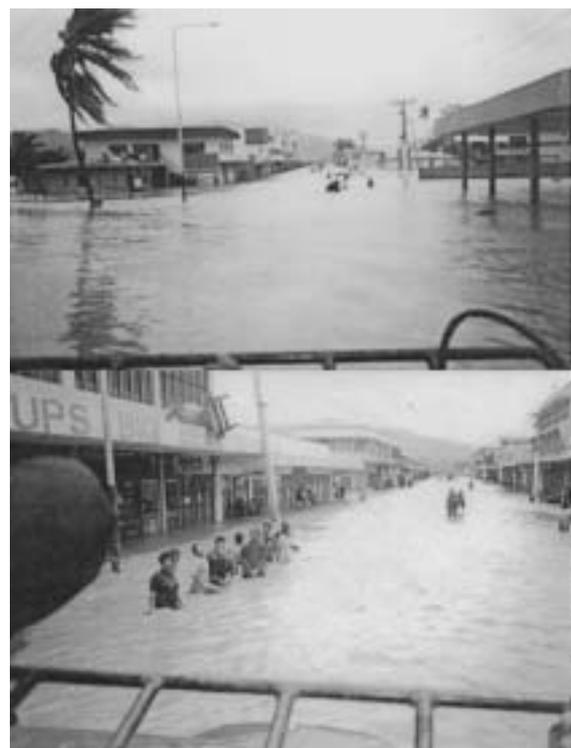
Fig 4. Severe flooding in Labasa Town on the northern coast of Vanua Levu island, generated by the combination of inundation by the sea (storm surge) and flooding of the Labasa River.

m³/s. The discharge at the same time of these large volumes of water from all three rivers to the same coastal plain was combined with a strong storm surge felt along the north coast of Vanua Levu. This resulted in terrible inundation to depths of 3 to 4 m above the floodplain, over a wide area around Labasa. This caused loss of life and unprecedented destruction of farms and houses across rural communities. Extensive infrastructure and property damage likewise was suffered in Labasa Town, the main urban and commercial centre for Vanua Levu and the Northern Division of Fiji (Fig. 4).

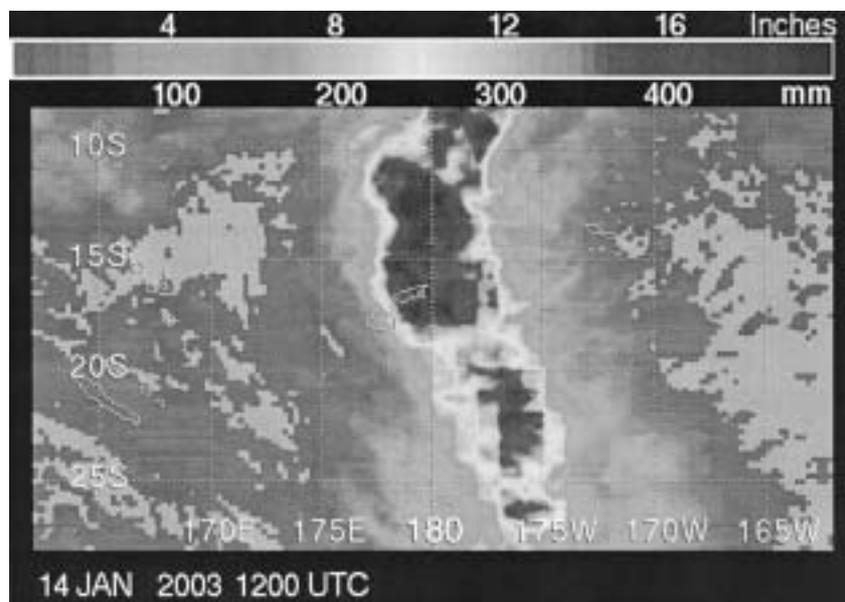
Fig 5. Cumulative precipitation totals delivered along the track of TC Ami as it traversed the Fiji Islands. Much of eastern Vanua Levu Island received >400 mm of rainfall (dark shading) during the passage of the cyclone.

A visual impression of the total cumulative precipitation along the storm path of TC Ami, across the Fiji Islands can be seen in Fig. 5. Dark shading shows the highest precipitation received. In addition, one-day (9 a.m. to 9 a.m.) rainfall figures for climate stations on Vanua Levu Island are given in Table 1. The data shows that large-scale rainfall was widespread. Of the 18 stations listed, 16 recorded more than 100 mm of rainfall in 24 hours. Of these, 5 received more than 200 mm. The majority of stations experienced their heaviest downpours on 13 January. Maximum recorded rainfall was 311 mm at the coastal site of Vatuwiri on Taveuni Island. Ami approached Fiji from the north, and Vatuwiri was on the windward coast beneath the highest mountain in the region (1241 m), and so the intense rainfall there reflects orographic effects.

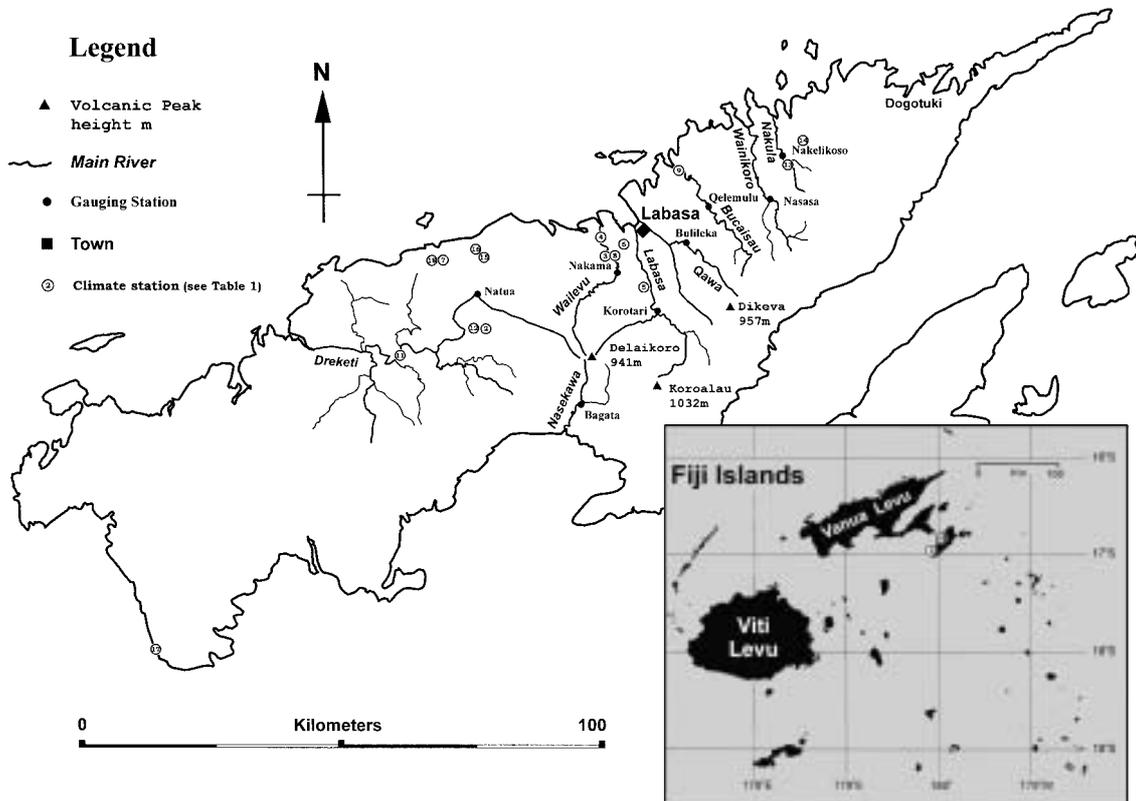
Fig 6. Major rivers and gauging stations on Vanua Levu Island operated by the Hydrology Division of the Fiji Public Works Department. Record flood discharges generated by TC Ami are discussed in the text.

the island. Flooding was carefully surveyed by the Hydrology Division of the Fiji Public Works Department at their long-term gauging stations, shortly after the flood waters receded. Locations of the rivers and their gauging stations are given in Fig. 6. To provide an idea of how these peak discharges corresponded to

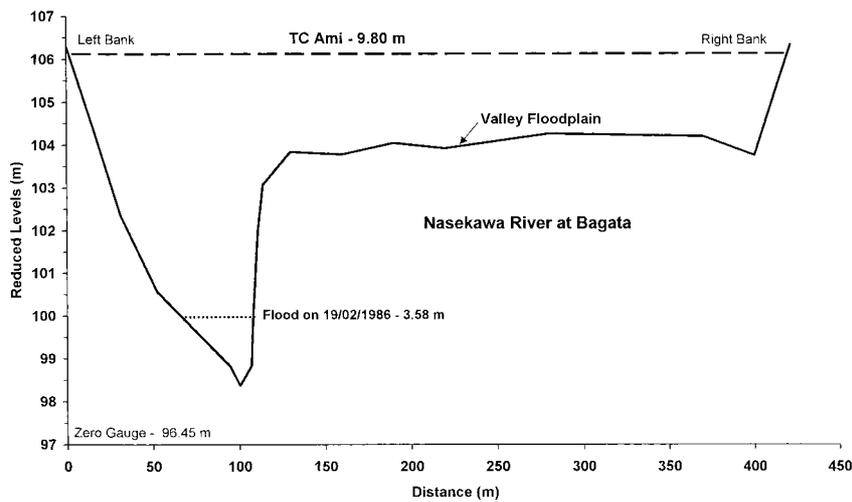
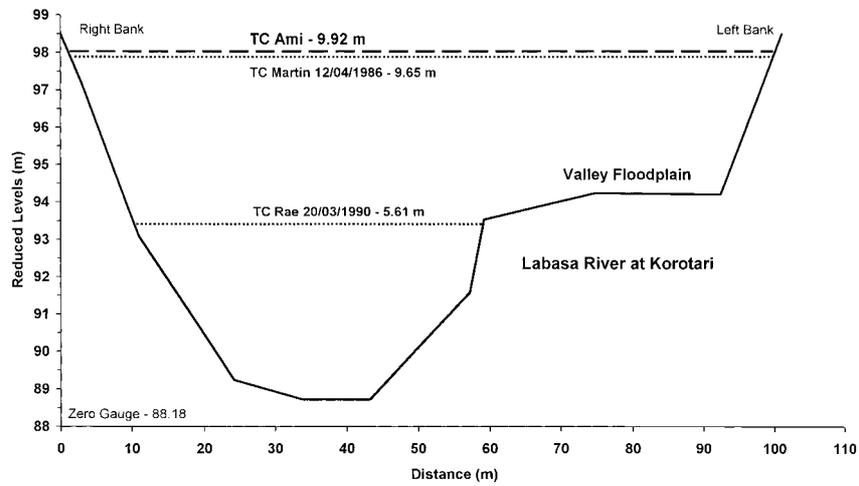
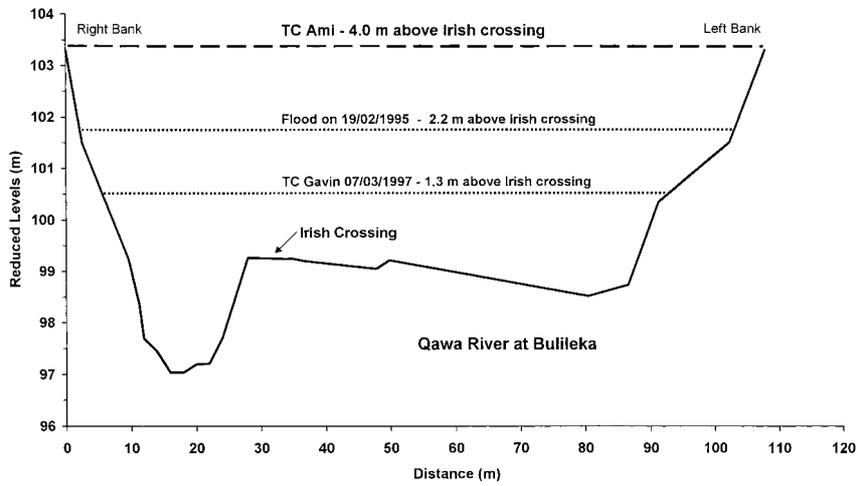
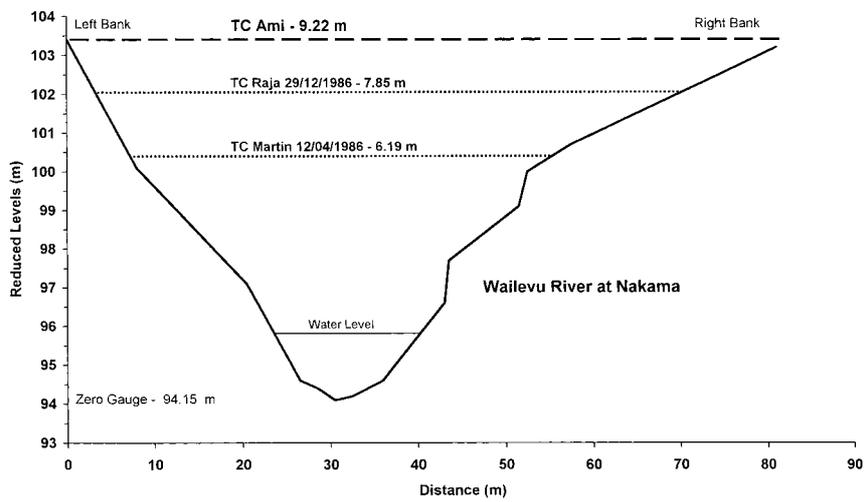
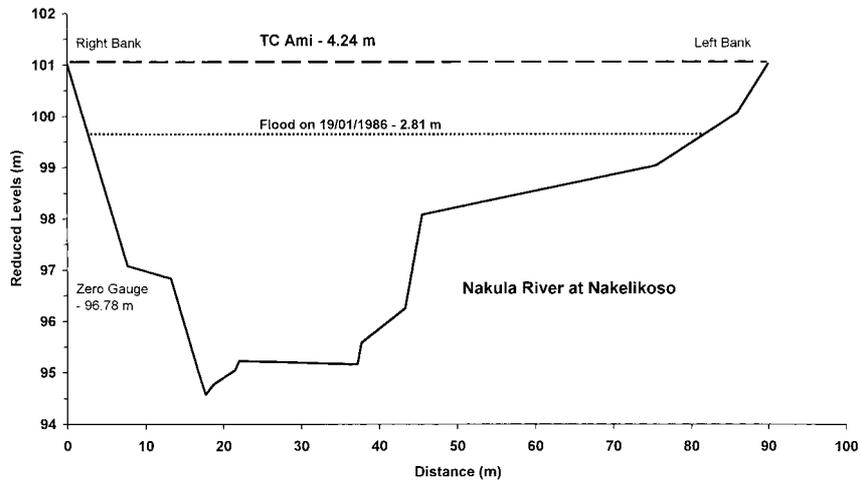
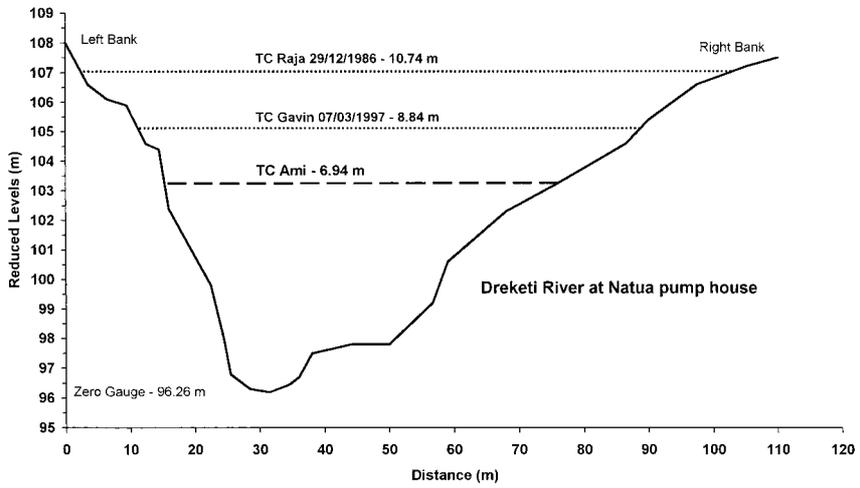
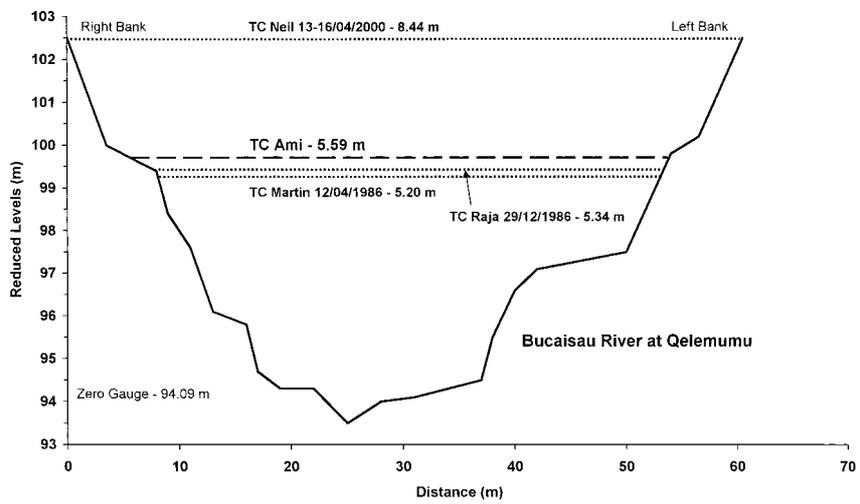
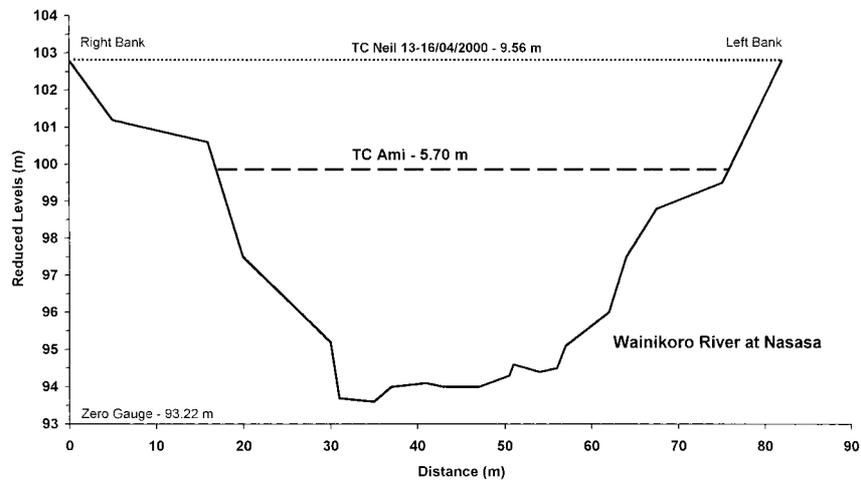
Fig 7.a-h Maximum flood heights produced by TC Ami in 8 rivers on Vanua Levu. Source: Fiji PWD Hydrology Division unpublished data.

flood height, river cross-sections are drawn in Fig. 7 a-h. TC Ami maximum flood levels are shown in comparison to those of other severe floods of recent decades. In 5 of the 8 rivers, Ami produced the largest floods on record. At the other 3 stations, the magnitude of Ami's deluge was surpassed only by other cyclone-generated

flood events. The Nasekawa, Labasa, Qawa, and Wailevu rivers all drain Vanua Levu’s most mountainous terrain (described earlier), in the centre of the island. The Nasekawa River had a phenomenal peak discharge of more than 6100 m³/s which destroyed the main highway bridge on the south coast at Bagata Village. On the north coast, the Labasa and Qawa rivers both drain into the same sheltered bay near Labasa Town, and the Wailevu River has its estuary only 4 km along the coast to the west. The peak flows in these rivers were all record-breaking ones, respectively 2377, 1802 and 2118
