Near Field Effects of Hidden Seismic Faulting on a Concrete Dam

ABSTRACT

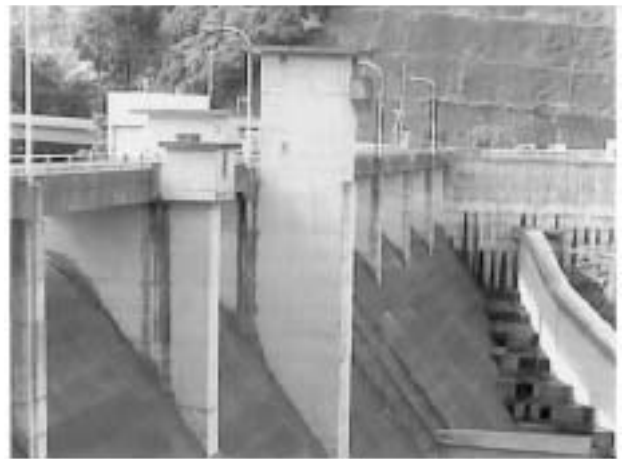
Fig. 3 Downstream views of Kashi Dam from the right bank.

Strong motion accelerometers at the dam registered a peak acceleration of 2051 gal at the top of the dam and 531 gal in the lower inspection gallery (Japan Commission on Large Dams, 2002). Despite such high acceleration, the dam body escaped serious damage, only suffering cracking of the concrete floor in its sub-gate control room. Although no increase in water leakage was recorded, the water level of the reservoir suddenly dropped 6 cm immediately after the main shock. This was followed by damped free vibration that continued for several hours. The drop in reservoir's water level was mysterious and raised concern among dam engineers.

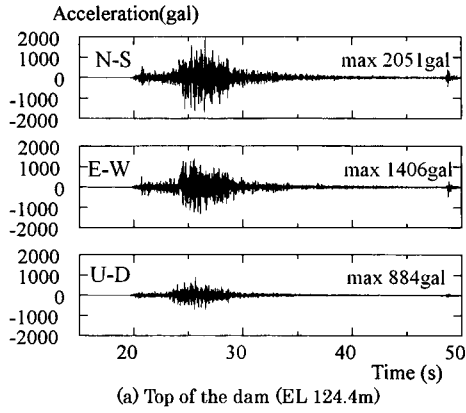
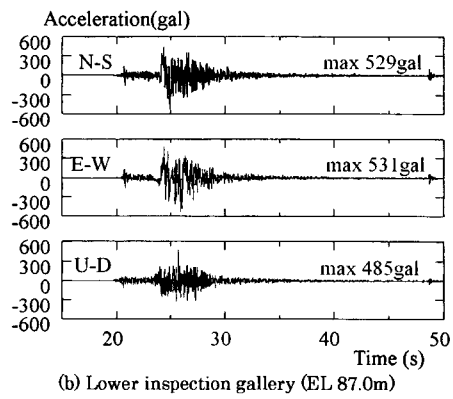
Fig.4 Strong-motion acceleration of the main shock recorded at Kasho Dam.

Acceleration records of the main shock obtained at the two seismometer installations are shown in Fig. 4. Earthquake acceleration was sampled at 100 Hz with 24-bit resolution and reliable from DC to 41 Hz. Seismic ground displacement was estimated by

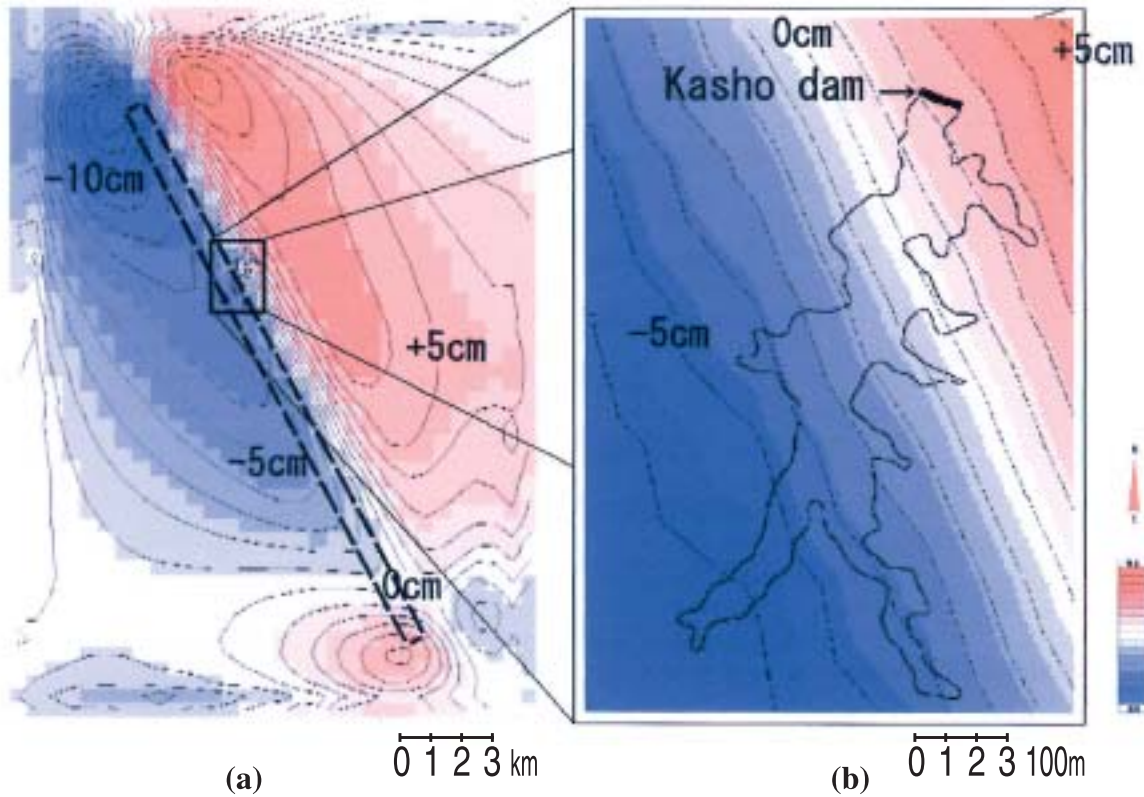
Fig. 7 Vertical ground displacement evaluated from the simulation by (a) BEM and (b) its interpolation (b)

Simulation was conducted on a rectangular area 23 km long (N-S) by 17 km wide (E-W) that encompassed Kasho Dam and its reservoir. The ground was simplified as a half-space of homogeneous elasticity with a shear wave velocity of 4 km/s. In the first step of the simulation, seismic ground displacement was calculated at every node of a $500\text{ m} \times 500\text{ m}$ mesh. Results are shown in Fig. 7(a), in which thick broken lines indicate the projection of the fault plane, thick solid lines the reservoir, and thin solid ones lines of equal displacement. The iso-displacement lines run almost parallel to the fault projection in the vicinity of the reservoir, indicating uplift of the reservoir to the northeast and settlement to the southwest.

The displacement in the area indicated by the thick solid lines in Fig. 7(a) was interpolated (Fig. 7(b)). The profile of the reservoir is drawn along the altitude of the design's flood water level (EL123.2 m). Kasho Dam is located at the north end of the reservoir.

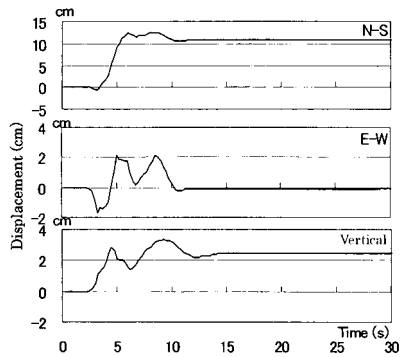
Fig. 8 Ground displacement at Kasho Dam simulated by BEM

Histories of ground displacement around the dam, obtained from interpolation of the simulated displacement, are plotted in Fig. 8. They appear very similar to the recorded displacement histories in Fig. 5, but the amplitudes are somewhat smaller. The sim-

ulated permanent ground displacement at the dam is 10.9 cm to the north and 0.1 cm to the west, with an uplift of 2.5 cm. The horizontal displacements shown in Figs. 5 and 8 are plotted in Fig. 9 in terms of motion trajectories. Interestingly, both trajectories in Fig. 9 have features in common; the direction of initial motion, elliptical motion in the final stage, and a large transient shift to the NE or NNE.

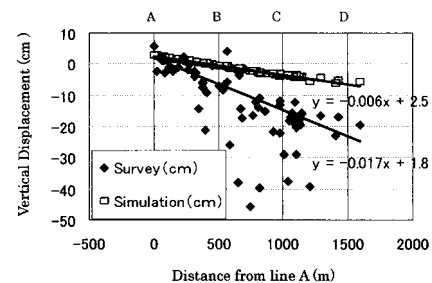
Fig. 11 Comparison of vertical displacements evaluated from the simulation and ground survey

After the main shock, a ground survey was conducted at 65 points along the reservoir. Figure 10 shows that the straight lines A to D parallel the fault projection in Fig. 7. With the distance from line A as the reference, the vertical displacements from the simulation and survey are plotted in Fig. 11. Displacements obtained from the survey are almost three times those obtained by simulation, particularly between lines B and C. The differences are attributable to several factors: the inaccuracy of parameters used in the

simulation and effects of local site conditions, as well as the effects of the many aftershocks, not considered in the simulation.

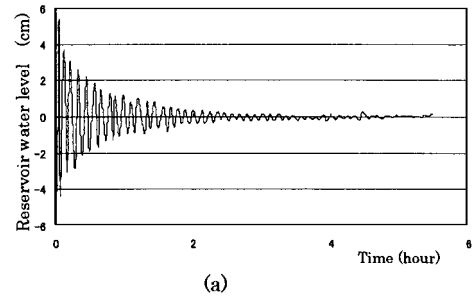
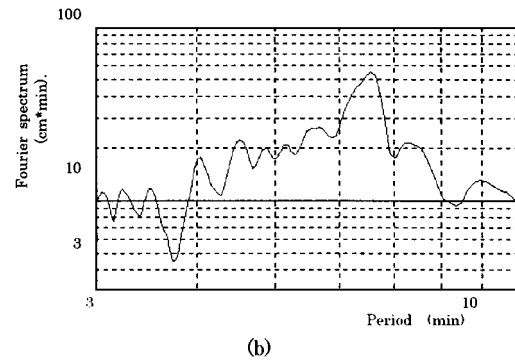
Fig. 14 (a) Reproduced free-vibration history of the water level and (b) the corresponding spectrum

The water level record was reproduced roughly from readings of successive peaks and troughs in the original record. The reproduced history and Fourier spectrum are shown in Fig. 14(a) and (b). The free-vibration characteristics estimated from these findings give a period of 6.5 min and a damping ratio of 2%.

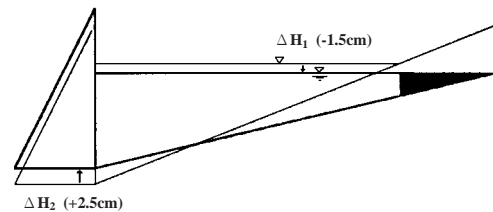
Fig. 15 Schematic explanation of the water level change caused by ground displacement

Seismic faulting caused uplifting of the dam body and change in the ground slope of the base of the reservoir as a result of near-field ground displacement. These factors are regarded to constitute the main cause of the sudden drop in the reservoir's water level. A schematic explanation is given in Fig. 15, in which the dam and ground slope before and after the main shock respectively are indicated by thin and thick lines. In the figure, ΔH_1 is the water level change due to the increased reservoir capacity estimated from the average settlement of the reservoir area, and ΔH_2 is the water level change due to the uplifting of the dam. The simulated displace-

ments (Fig. 7) give ΔH_1 of -1.5 cm and ΔH_2 of 2.5 cm, with a corresponding water level change of -4.0 cm ($\Delta H = \Delta H_1 + \Delta H_2$), which is in reasonable agreement with the observed -6.0 cm.

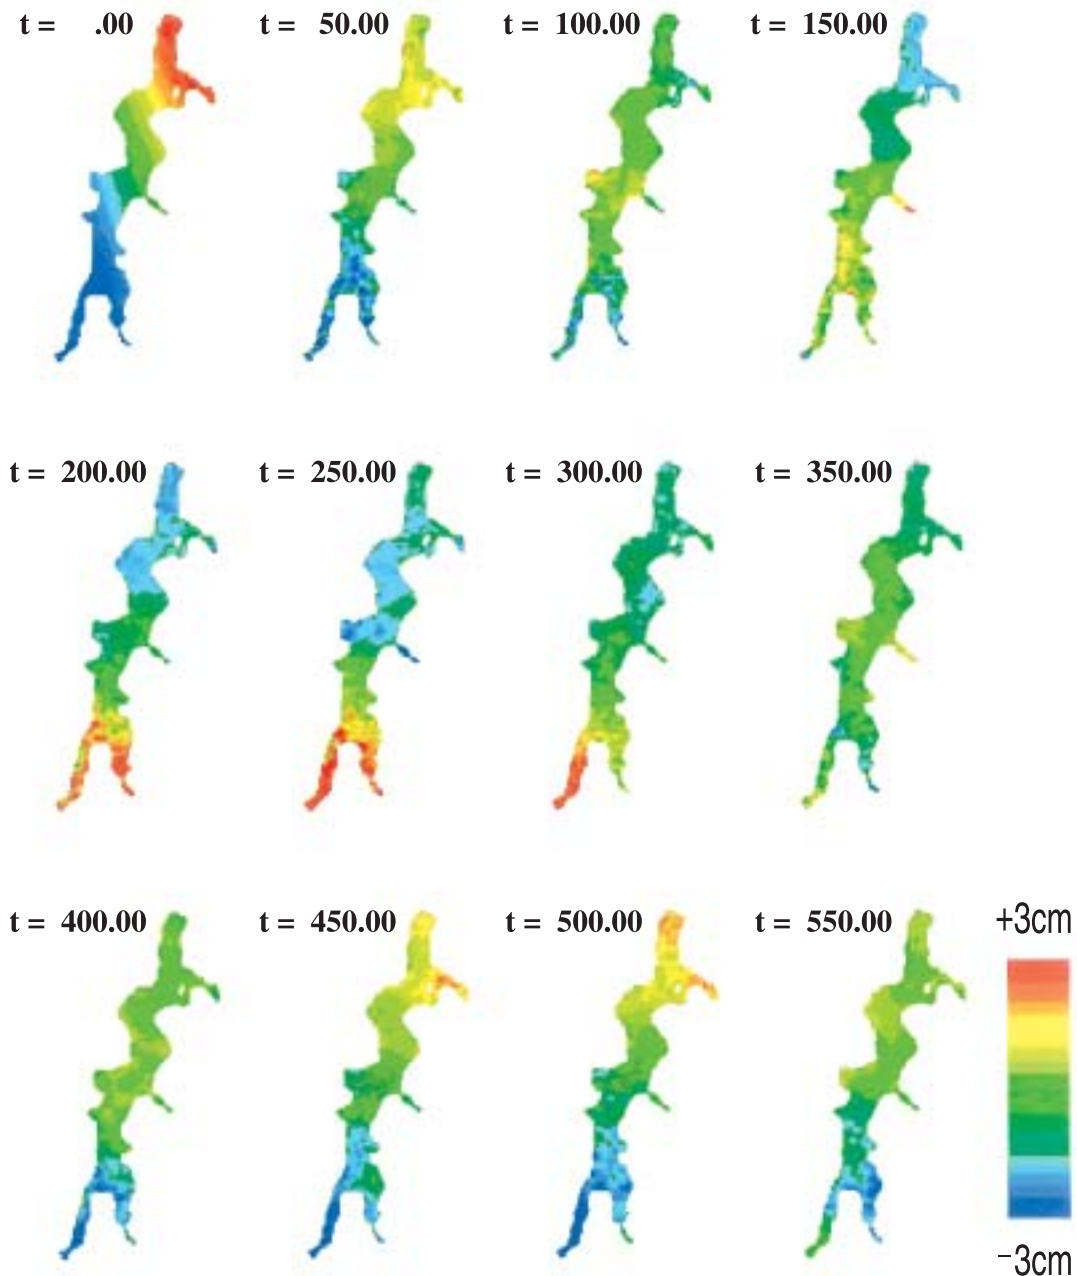
Fig. 16 Water surface of the simulated seiche (time unit : s)

In Fig. 16, the reservoir's water surface has a uniform slope at $t = 0$, the highest water level being at the dam and the lowest at the

upstream end. After 200 s, about half of the seiche period, the highest point is at the upstream end and lowest at the dam. After 450 s, the water surface again resembles the initial shape. The water surface pivots on an axis in the middle of the reservoir, indicative that its free vibration motion primarily is due to the fundamental mode of the seiche.

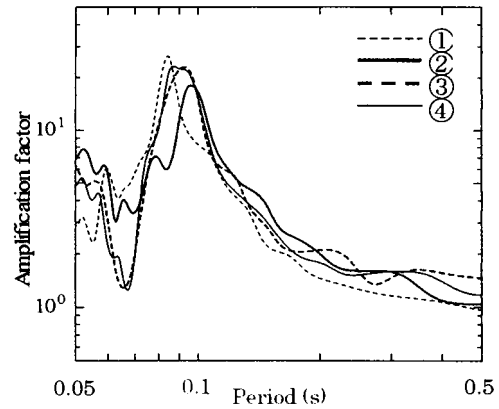
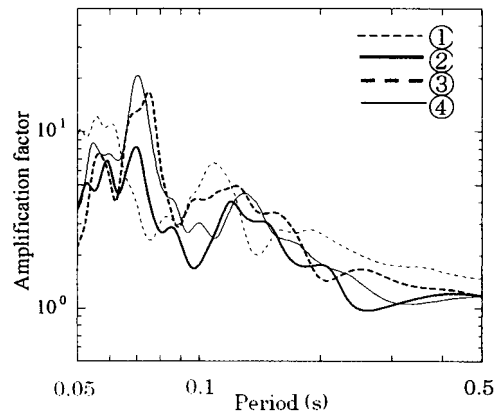
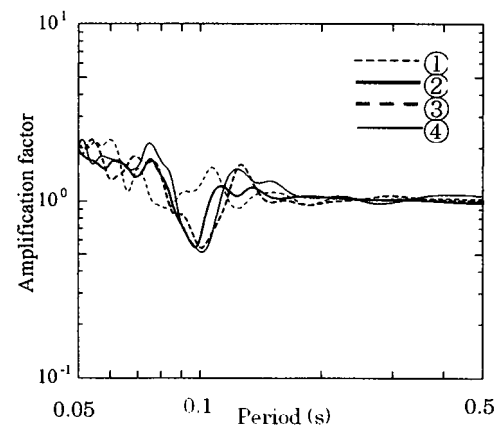
Fig. 19 Amplification factors between the dam top and lower inspection gallery

Acceleration histories were divided into four 5.12-s segments (Fig. 18). At the top of the dam, the peak accelerations in the upstream-downstream direction in these segments were 491, 2100, 531 and 227 gal. The amplification factors between the top and lower gallery, calculated from the Fourier spectral ratios between pairs of segments, are shown in Fig. 19. In the upstream-downstream direction, the main peak is about 0.1 s, and appears to be
