Reconnaissance report of the 2004 Great Sumatra-Andaman, Indonesia, Earthquake – Damage to geotechnical works in Banda Aceh and Meulaboh –

Tetsuo TOBITA¹, Susumu IAI¹, Banta CHAIRULLAH² and Wimpie ASPER³

¹ Disaster Prevention Research Institute (DPRI), Kyoto University

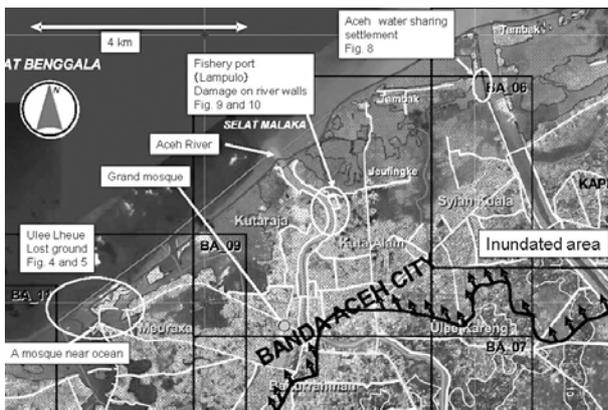
that form the coastline of Banda Aceh. Buildings or houses located from 3 to 5 km inland were affected by a tsunami as shown in Fig. 2. The height of the tsunami in Banda Aceh ranged from 5 to 30 m (Tsuji *et al.*, 2005). The inundated area is shown with a black line with small arrows in Fig. 2.

Fig. 2 Inundated area of Banda Aceh (DLR, 2005)

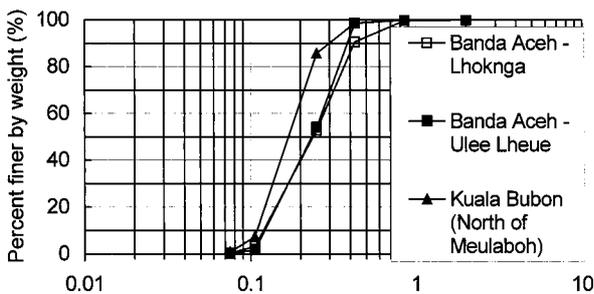
Fig. 6 Grain size distribution curve of sand samples collected at Banda Ache and Meulaboh

Eyewitness reports of water coming out from the cracked floors of houses accounts for the occurrence of liquefaction in Kuala Bubon. The soil was sandy and the grain size distribution analysis of the sand collected in Kuala Bubon reveals the possibility of liquefaction (Fig. 6). The combined effects of liquefaction and tsunami might be responsible for the submersion of land near the deltas. Other eyewitness reports of liquefaction and sand boils

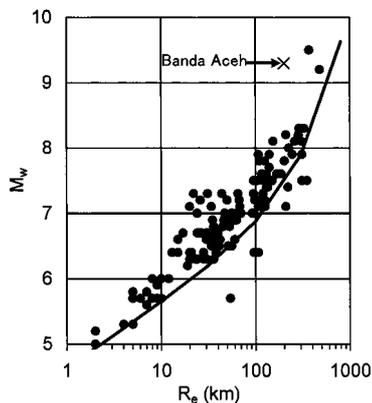
Results of the reconnaissance indicate that the loss of land along coastlines submerged into the sea was mainly due to erosion by the hydrodynamic force of tsunamis; however, liquefaction also likely contributed. According to the witness accounts of residents, liquefaction occurred before the tsunami struck. The sites consist of clean sand with an average particle size of 0.2 - 0.3 mm (Fig. 6). The epicentral distance of the liquefied site in Banda Aceh, although it might not be the farthest site for this event, can be plotted in the figure developed by Ambraseys (1988) from the worldwide database of shallow earthquakes (Fig. 7). As seen in Fig. 7, the distance between Banda Aceh and an epicenter of 250 km for an earthquake of M_w 9.3 is consistent with existing findings.

Fig. 7 Maximum epicentral distance to liquefied sites R_e and moment magnitude M_w (after Ambraseys 1988)

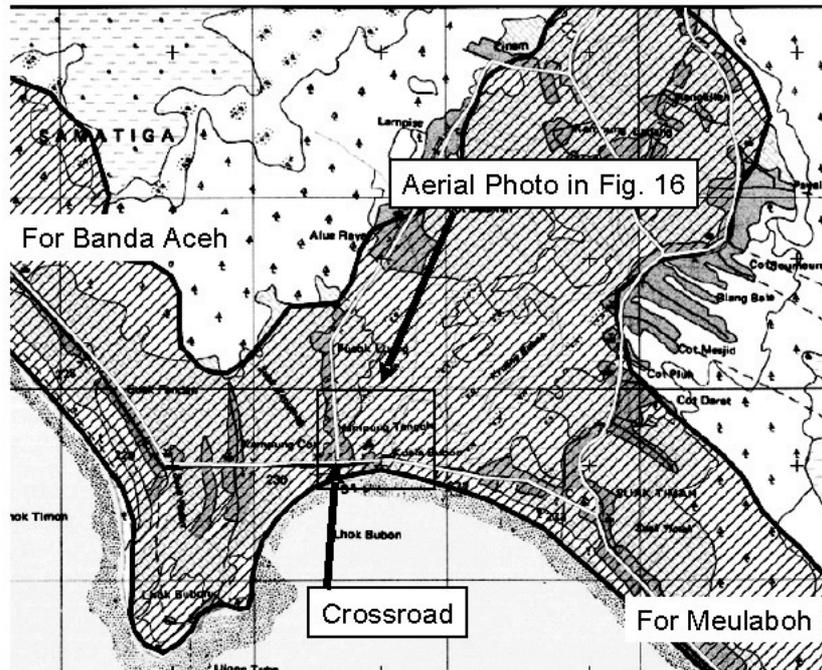
Fig. 13 Inundated area in Kuala Bubon and the direction of the aerial photograph shown in Fig. 16 (DLR, 2005).

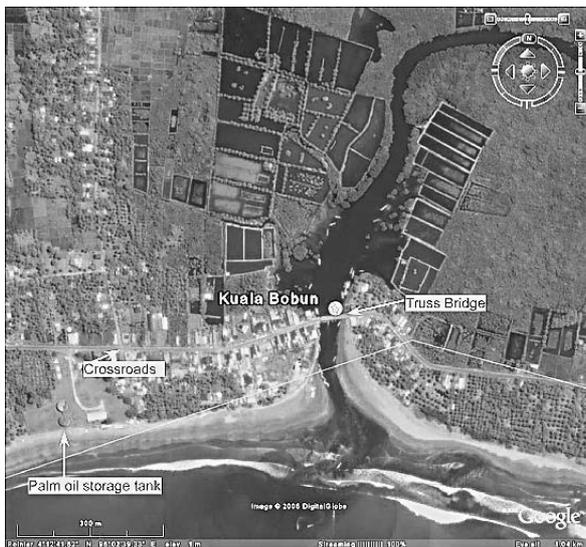
Fig. 14 Satellite image of Kuala Bubon before the earthquake and tsunami (Google Earth)

There was a 60 m steel truss bridge at the river estuary of Bubon River (Fig. 14). Its girders fell and only two bridge abutments are left (Fig. 18). Wave force is responsible for the bridge
